Success Stories

Luas Tram Line, Dublin

Civic Group Ltd
Luas Tram Line, Dublin
Repair of damaged concrete
QC10 F

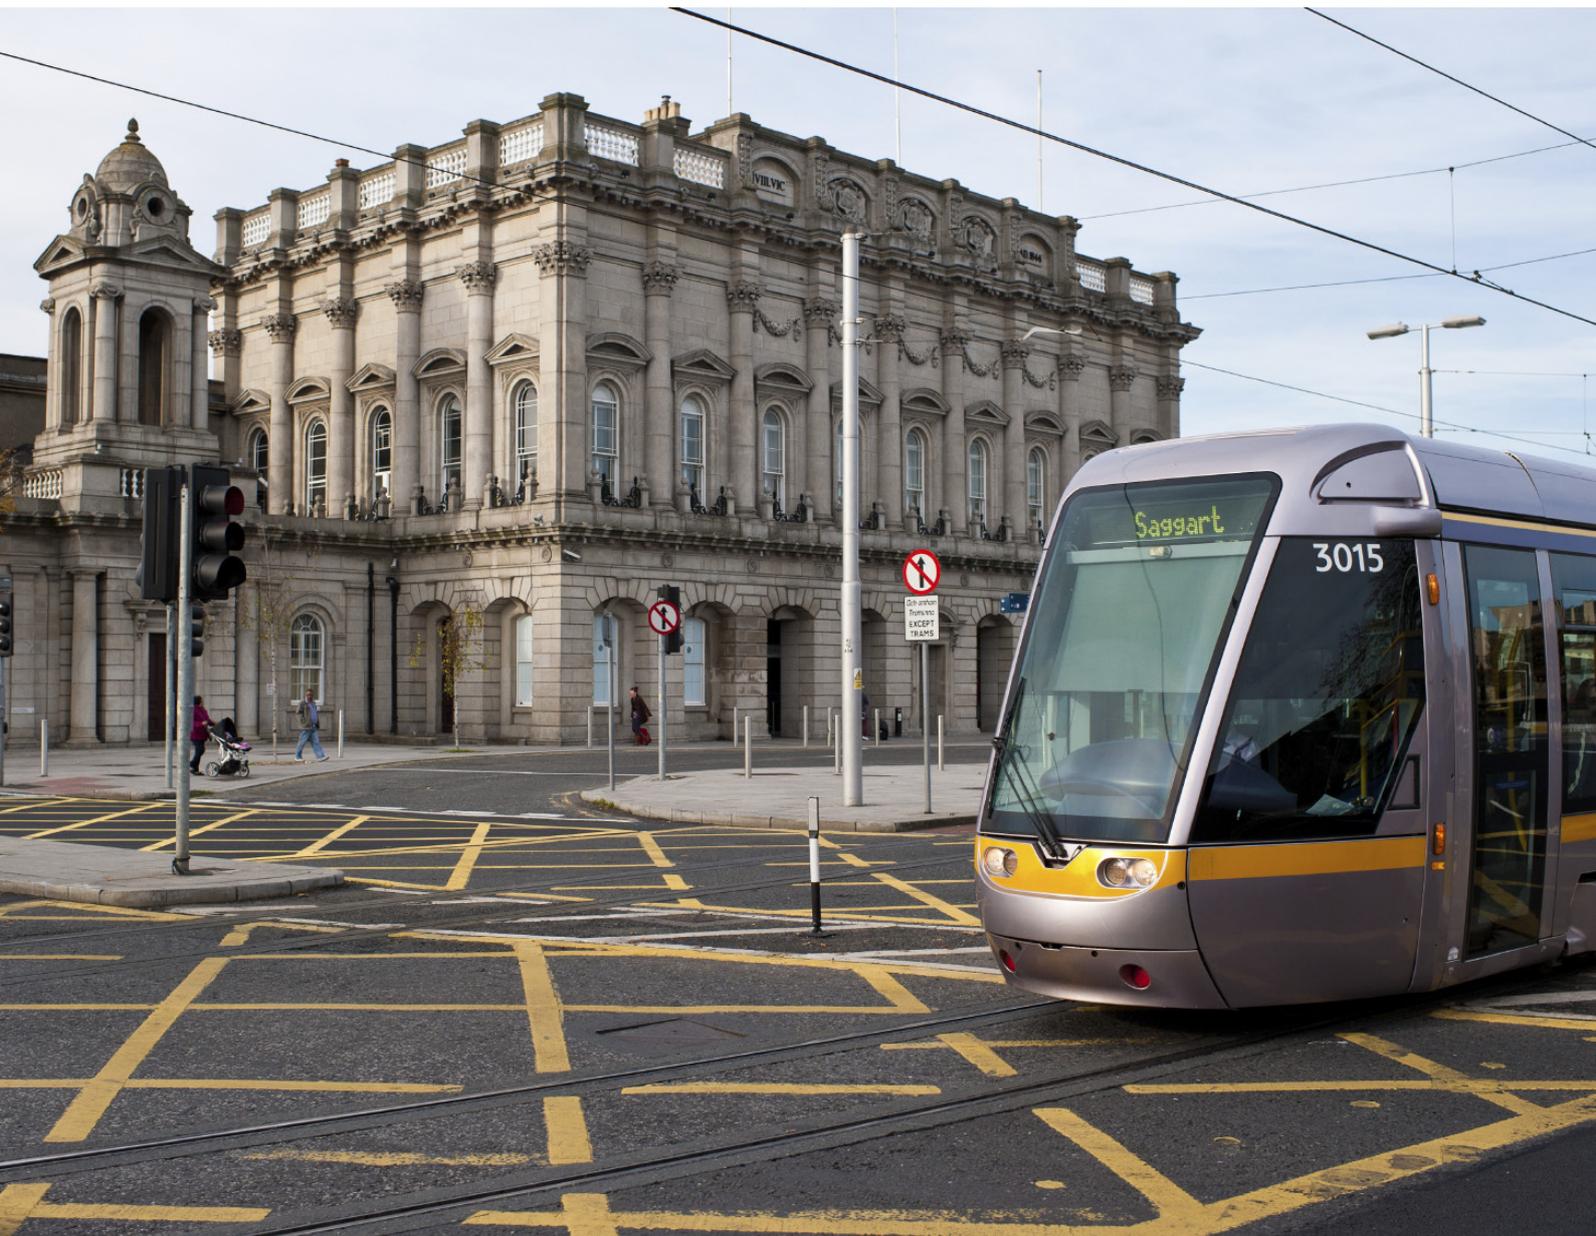
A section of embedded track concrete shoulder, adjacent to the road surface, was under stress because the installation material had failed. Ultracrete recommended the use of its QC10 F flowable, fast set, rapid strength concrete to resolve the issue.

In this instance it was used as a surface repair and was installed by maintenance contractor Civic Group Ltd, who carried out the reinstatement overnight during a tight time frame of just four hours, to ensure minimal disruption to the tram and its commuters. Existing material was broken out, before QC10 F was poured into the void around the girder rails.
