Steel Facts

Number 6

Newer fuels and storage tank corrosion

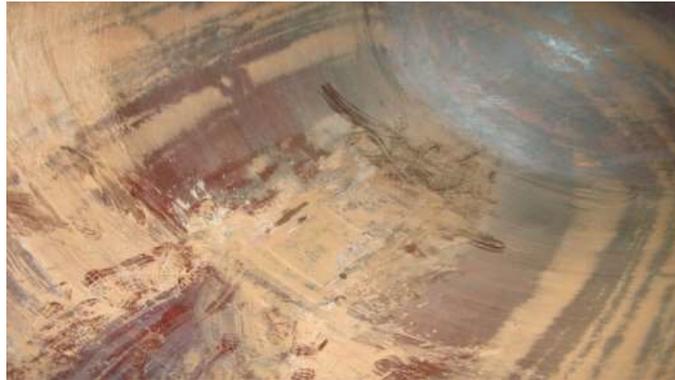
ASTSWMO Case summary #1: Damaged Internal Lining (FRP)

Fiberglass reinforced plastic (FRP) tanks, on the other hand, have developed cracks, blisters, and delamination, believed to be caused by storage of ethanol.

The study observed 22 cases of tank corrosion and failure, 10 of which were biofuel storage tank failures. Nine of those failures were in fiberglass reinforced plastic (FRP) tanks. The tenth was a steel tank that was determined to have had a hole breach prior to the storage of E85.

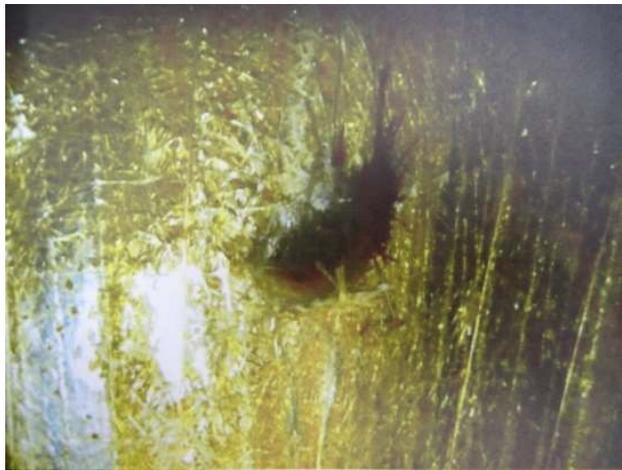
ASTSWMO Case summary #20: UST fibers exposed due to chemical exposure (FRP)
