Case Study: 17842 Sikalastic Low Level Roof Refurb

Location
Physio Therapy, Heatherwood Hospital, Ascot

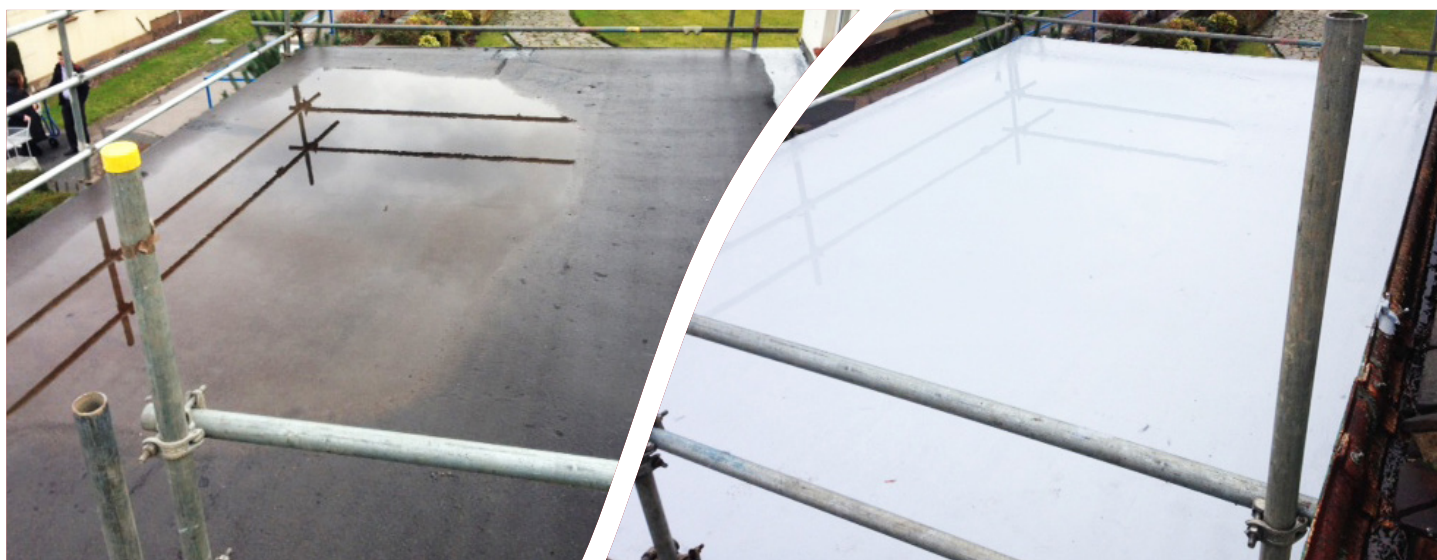
Water ingress into the building through the failed Asphalt roof surface.

Adamson Construction erected scaffolding access tower and full edge protection. The roof surface was cleaned with Sika Biowash to kill all fungal growth. Small local repairs were carried out and existing sub-standard repairs were removed.

The first coat of Sikalastic – 618, 1.5L/m² was the applied before the dressing of the Sika Ree-mat into embedment coat whilst wet.

This was allowed to set and then the second coat was applied at 0.75L/m², making sure that all pinholes were filled.
