TEST REPORT

No. : XMIN1502000923PS

Sample Name : OIL DRUM
SGS Ref. No. : GZIN1502006572MR-01
Product Specification : 20L
Date of Receipt : Feb 12, 2015
Date of second Receipt : Jun 17, 2015
Testing Start Date : Feb 12, 2015
Testing End Date : Jun 17, 2015
Test result(s) : For further details, please refer to the following page(s)

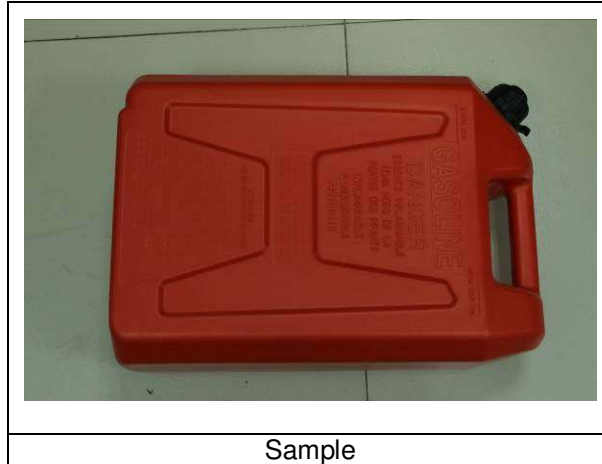
Test Photo:

Sample Description: See photo

Test Item	Requirement in AS/NZS 2906:2001 Section 6	Conclusion
Closures and Gaskets	(a) All closures shall be designed to allow effective sealing without the use of tools so that the container, other than a tank, will be hermetically sealed in normal use. Threaded closures shall be designed to seal at a torque not greater than 5 N·m. (b) Gaskets, where used, shall be installed with a retaining ring or other means of preventing accidental loss.	Pass The seal at a torque is 3.0 N·m.
Filling Opening	The filling opening shall be designed to allow free entry of common, fuel-dispensing nozzles. The opening shall be not less than 25 mm in diameter nor more than 70 mm in diameter.	Pass The diameter of filling opening is 35 mm.

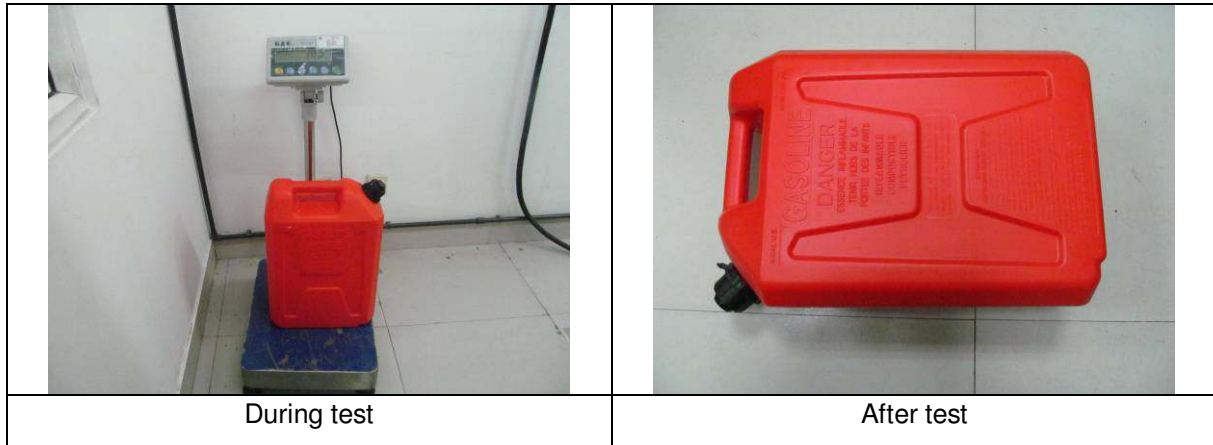
Test Photo:

- Condition: ① After test item 3, empty the sample and stabilize at 23 ± 2 °C for 24 h
- ② Fill with 60 °C water, 120 kPa hydraulic pressure, 5 min → 180 kPa hydraulic pressure, 30 min
- ③ Empty the sample and stabilize at 23 ± 2 °C for 24 h

Test Item	Test Result	Requirement in AS/NZS 2906:2001 Section 7.3.2	Conclusion
Hydrostatic Pressure Test	No evidence of leakage	No evidence of leakage	Pass
Stability Test	The specimen remain on its base unsupported	The specimen shall remain on its base unsupported	Pass

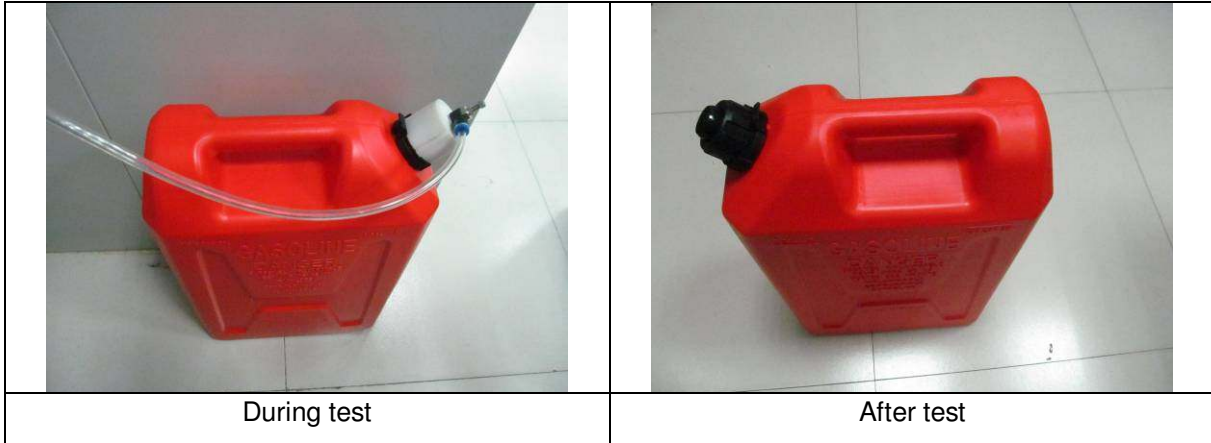
Test Photo:

②Fill with water, -18 °C, 2 h →Take out and do the test immediately

Drop height: 1200 mm

Test Item	Test Result		Requirement in AS/NZS 2906:2001 Section 7.3.4	Conclusion
Drop Strength Test	Direction 1	No rupture, no leakage	Specimen shall show no sign of rupture or leakage after the specimen has been vented and left to stand for a period of not less than 5 min.	Pass
	Direction 2	No rupture, no leakage		
	Direction 3	No rupture, no leakage		
	Direction 4	No rupture, no leakage		
	Direction 5	No rupture, no leakage		
	Direction 6	No rupture, no leakage

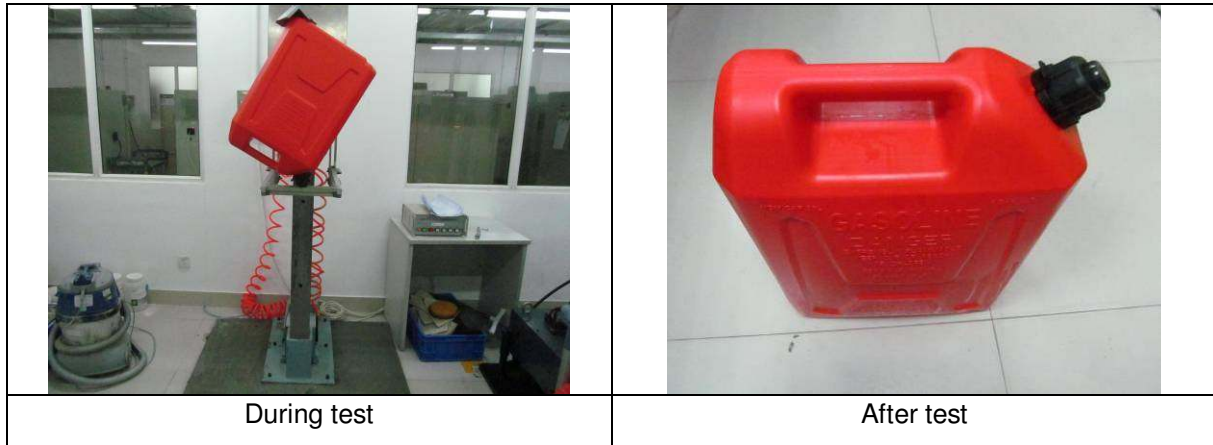
Test Photo:

Test Condition: Round test tray: 600mm in diameter, 13mm high

5L motor spirit in the fuel container

0.75L motor spirit in the round test tray

Test Item	Test Result		Requirement in AS/NZS 2906:2001 Section 7.3.5	Conclusion
Determination of integrity of fuel containers when exposed to flame	Sample 1	The sample doesn't lose its integrity in 30s and doesn't explode in 90s	Sample shall have a time to 'loss of integrity' of not less than 30 s and shall not explode in less than 90 s.	Pass
	Sample 2	The sample doesn't lose its integrity in 30s and doesn't explode in 90s		
	Sample 3	The sample doesn't lose its integrity in 30s and doesn't explode in 90s		
	Sample 4	The sample doesn't lose its integrity in 30s and doesn't explode in 90s

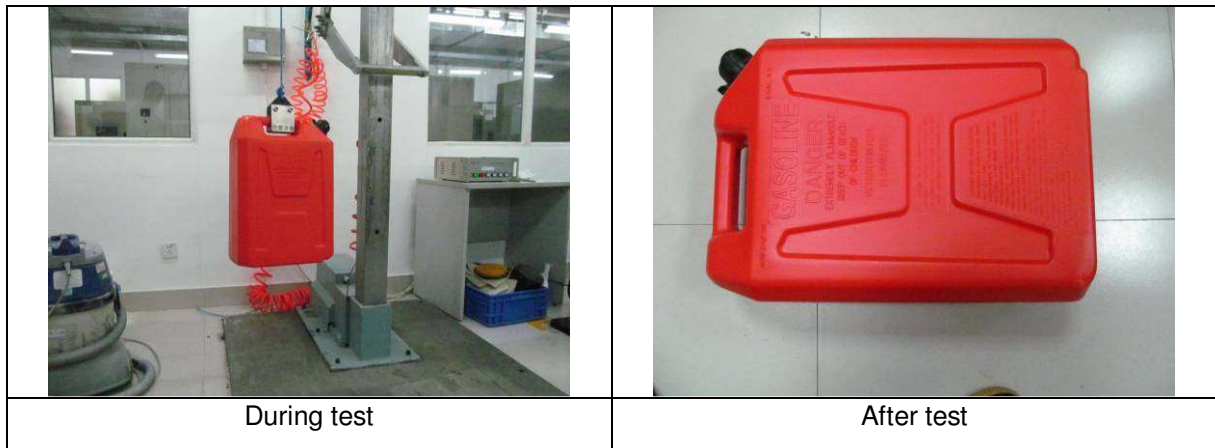
Test Photo:

Condition: ① After test item 5, fill with 10 L water, 23 ± 2 °C, 6 h

Drop height: 305 mm

Test Item	Test Result	Requirement in AS/NZS 2906:2001 Section 7.3.6	Conclusion
Handle Strength Test	No separation of the handle, no leakage	There shall be no complete separation of the handle at any point of attachment to the specimen, nor there shall be any leakage from the specimen. When evidence of partial separation of the handle of the specimen is present, the test shall be repeated once more, as specified, on the same handle of that specimen. There shall be no further separation after the repeated test.	Pass

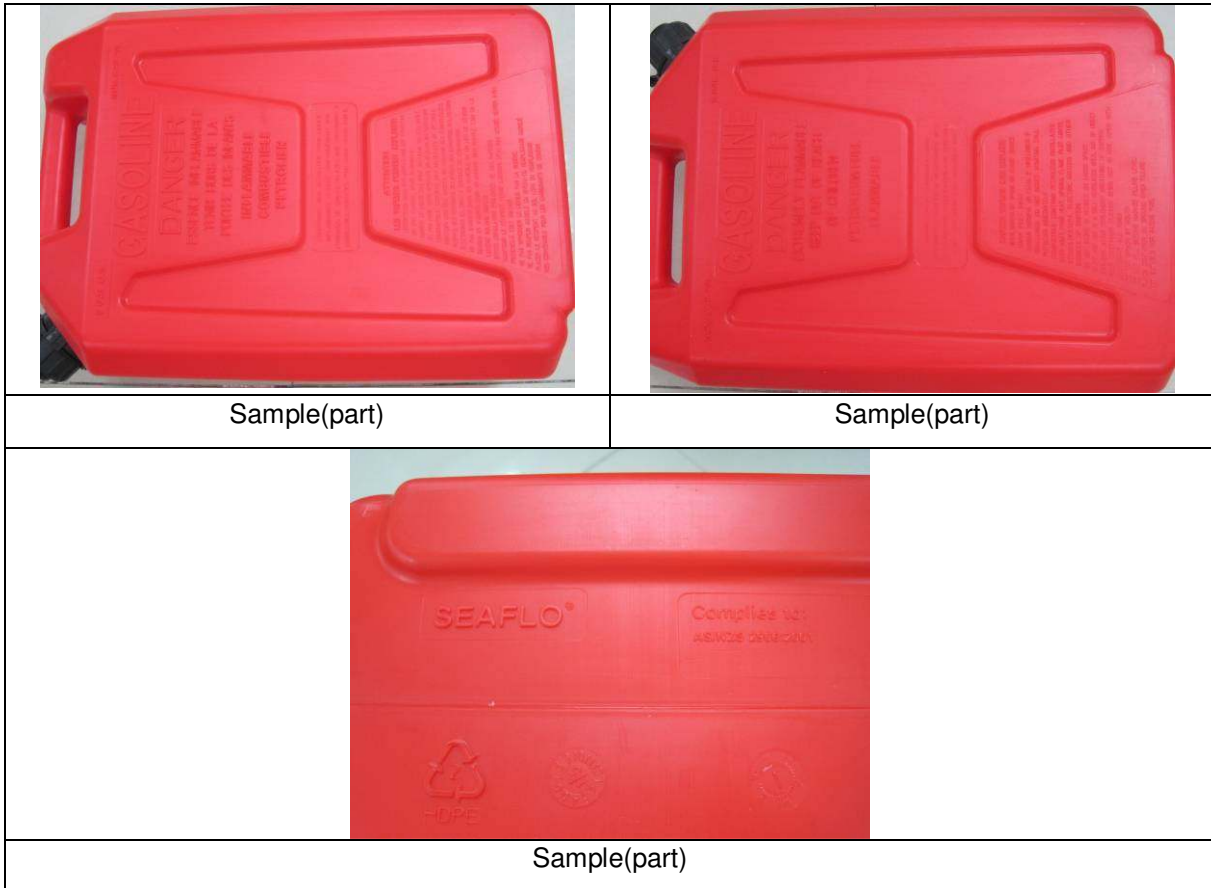
Test Photo:

Requirement in AS/NZS 2906:2001 Section 8	Conclusion
<p>Each container shall be dumbly and indelibly marked (e.g. embossed or moulded) with the following, in characters not less than 3 mm in height for capital letters and for lower case letters with an ascender or descender, or not less than 2 mm in height for lower case letters without an ascender or descender:</p> <p>(a) Manufacturer's name or registered trademark.</p> <p>(b) Nominal capacity. in litres, in conjunction with a mark indicating that level</p> <p>(c) An indication of the year of manufacture of the container and, for plastics containers, also the month of manufacture.</p>	<p>PASS</p> <p>The letters are embossed, the minimum capital letter height is 3.42 mm, No lower case letter.</p> <p>(a) "SEAFLO"</p> <p>(b) "NOM.CAP.20L"</p> <p>(c) "Jun, 2015"</p>

<p>Each container shall display the following:</p> <ul style="list-style-type: none"> (i) A word indicating the hazardous nature of the contents of the container, i.e. "Warning", "Danger", or "Caution". (ii) The warnings, "Vapour may cause flash fire" or similar, "Fuel only" or similar, and "Flammable". (iii) Any phrase indicating appropriate cautionary statements, e.g. "Keep out of the reach of children", "Not suitable for racing fuel". (iv) First aid information, which shall include advice on actions to be taken if fuel is swallowed, inhaled, or comes in contact with the skin or eyes, e.g. as required by the National Health and Medical Research Council. 	<p>PASS</p> <ul style="list-style-type: none"> (i) "DANGER" (ii) "FLAMMABLE" (iii) "KEEP OUT OF THE REACH OF CHILDREN " (iv) "DANGER HARMFUL OR FATAL IF SWALLOWED.IF SWALLOWED, DO NOT VOMITING.CALL PHYSICIAN IMMEDIATELY"
---	--
