Case Study: 18384 Thorpe Park, Bar 360 Refurbishment Works

Location
Bar 360, Thorpe Park, Chertsey

Refurbishment / Demolition / Plastering & Rendering / Civil Engineering / Cladding / Roofing

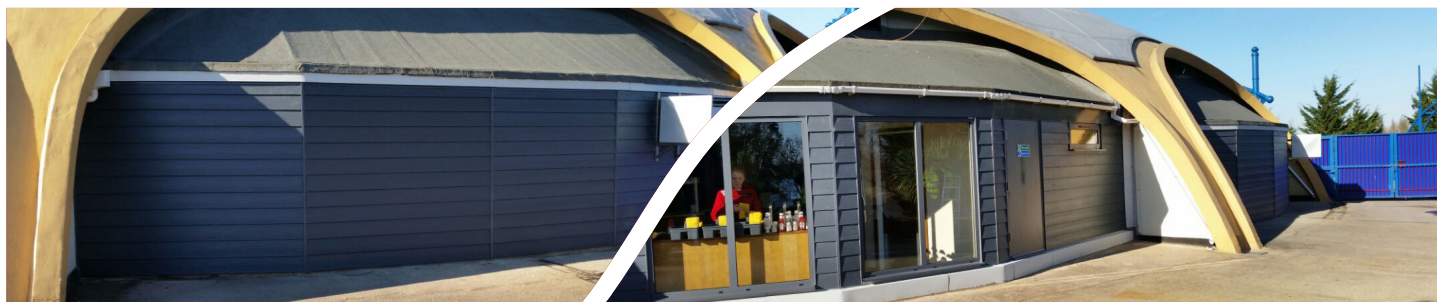
Water ingress was causing damp issues on lower part of walling which in turn was causing a number of other problems including the timber studwork to rot. The existing flooring was de-bonding and decorations were becoming dis-coloured.

Firstly although the park was closed it still had to be segregated from the park staff. Site sheeting and containment was installed externally to the area. The existing cladded walling and rotten studwork was demolished and support props were installed to support roof edge as works progressed.

A cast in-situ waterproof Concrete beam was installed at foot of cladded wall. The timber studwork was then erected and the external face was lined with breathable waterproof fabric before the studs were infilled with Rockwool insulation.

Three aluminium windows frames with high performance glass were installed along with fire exit door. Marley Cladding was then installed to finish the external face and match with existing.

12.5mm S/E plasterboard was affixed to the internal face and the area was then skimmed with multi-finish. The existing roof edge was dressed and drip bead affixed, before external flooring dressed to complete.
