RP 17035

COMPLIANCE SYSTEM REPLACEMENT

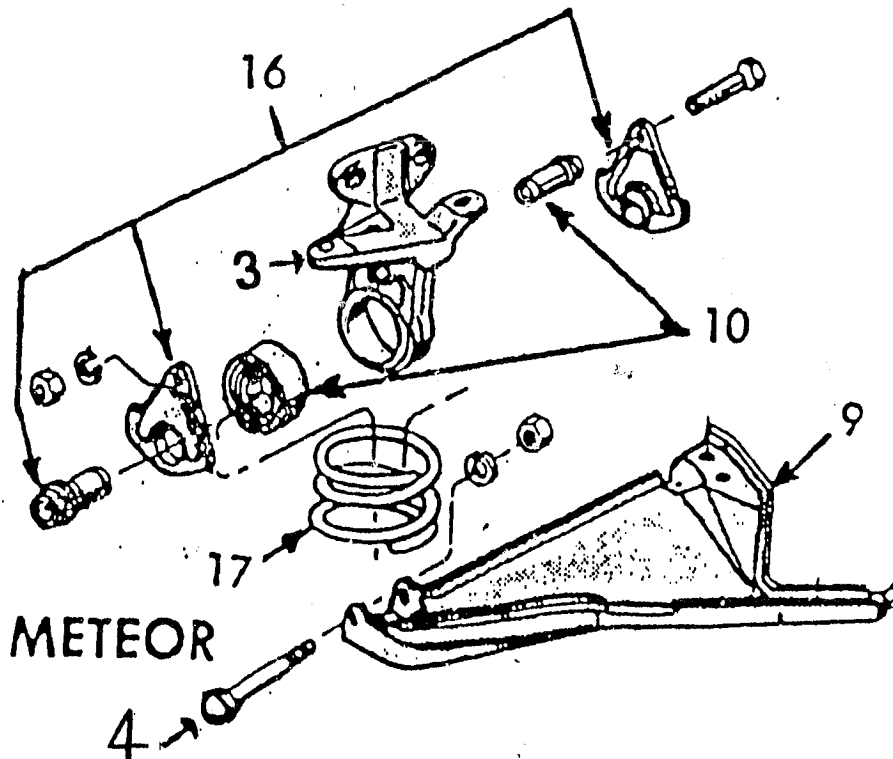
THIS REPLACEMENT BUSHING ELIMINATES THE NEED FOR ITEM #10 (2 BUSHINGS), ITEM #16 (1 BUSHING AND 2 SHACKLE PLATES) AND ITEM #17 (SPRING).

INSTALL OUR REPLACEMENT BUSHING BY PRESSING IT INTO BRACKET #3 FROM THE FRONT SIDE (LARGE DIAMETER ON THE BUSHING TOWARD THE FRONT OF THE CAR). NOTE: MAKE SURE THE THIN OUTER SHELL OF THE OLD BUSHING HAS BEEN COMPLETELY REMOVED FROM THE BRACKET.

REINSTALL BRACKET #9 WITH BOLT #4 THROUGH THE NEW BUSHING. PUT THE WEIGHT OF THE VEHICLE ON THE WHEELS BEFORE FINAL TIGHTENING OF BOLT #4 AND THE BOLT AT THE INNER END OF THE LOWER CONTROL ARM.

REMOVE AND DISCARD ITEMS 10, 16 AND 17.

TIGHTEN TO MANUFACTURER'S SPECIFICATIONS AND HAVE THE CAR ALIGNED BEFORE PUTTING IT BACK INTO SERVICE.
