STUKELEY STREET, LONDON

Client: Building Fabric Maintenance **Products Used:** Sika®-1 Mortar
Render Additive

Overview

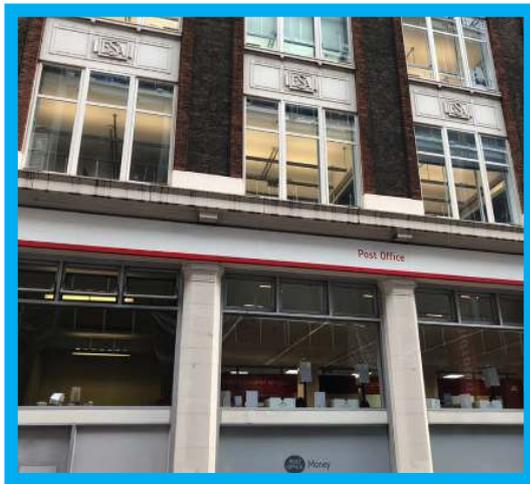
When water entered the building it was being pumped out via a pump situated on the retaining wall. It was also made apparent that the River Fleet and old tunnels are within close proximity of the wall so if heavy rainfall were to occur out of office hours the water would travel across the floor, down corridors and flooding that part of the building.

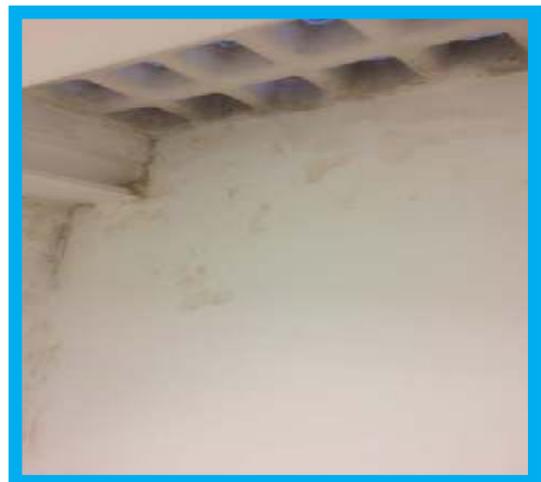
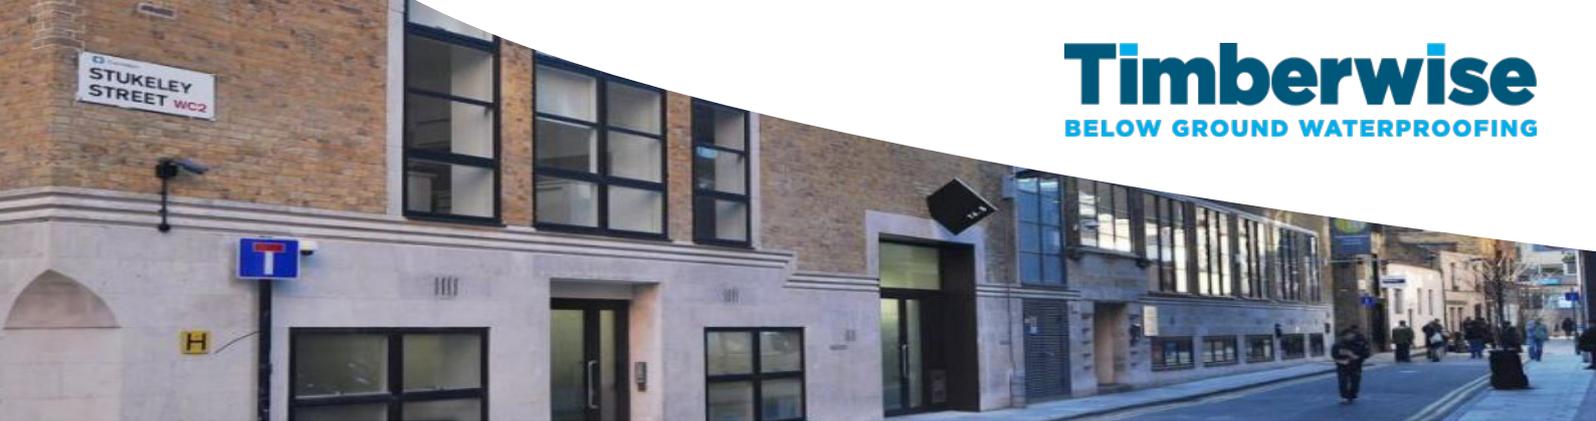
Prior to the work starting, dustsheets were taped down and hardboard was applied to the floor in order to reduce dust settling. All existing dry lining and wall plaster was removed and the debris bagged up and disposed of.

Timberwise operatives removed the existing plasterboard linings to expose the substrate beneath. The substrate was found to be brickwork however, this was painted, thus requiring further preparation to create a suitable 'key' for the waterproofing render to adhere to. Timberwise operatives then cut back the floor solid floor screed by 200mm to form a wall floor joint to secure a flexible movement jointing strip (combi flex).

The application of the Sika waterproofing system was then carried out, as detailed within the Sika 1 specification below.

First Coat: covering the surface completely with the first coat of Sika®-1 mortar

Second Coat: after the first coat had stiffened sufficiently another coat of Sika®-1 mortar is applied.

Third Coat: the third coat of Sika®-1 mortar is applied however this is mixed to a less viscous consistency.
