**Project Information**Project Name  
**Brunel House**

Date:  
**04/05/2017**

# Site Report

We attended site to conduct a CCTV drain survey of all underground drains, to provide drawings outlining their locations and to provide recommendations for remedial works that may be required.

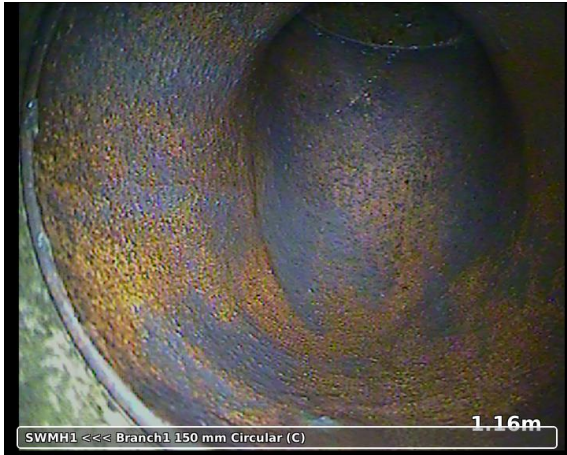
, 00:00:37, 1.16m  
Survey abandoned / Enters bottom of RWDP

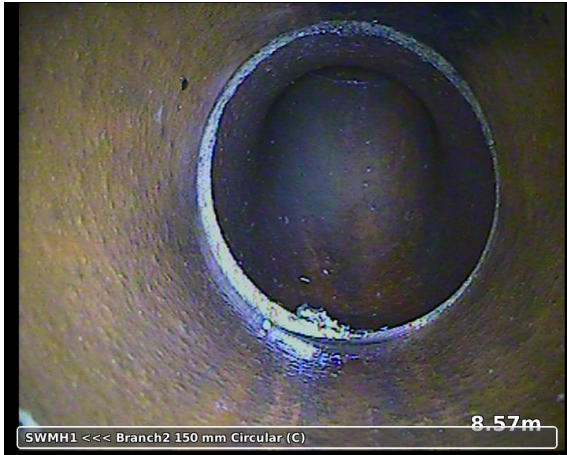
, 00:00:50, 8.57m  
Survey abandoned / Enters bottom of RWDP

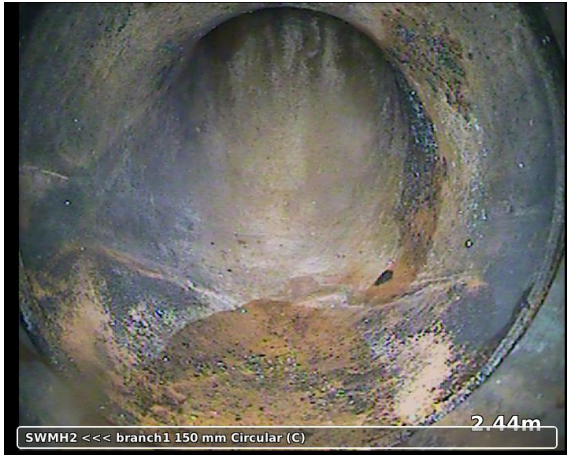
, 00:00:43, 2.44m  
Survey abandoned / Enters bottom of RWDP

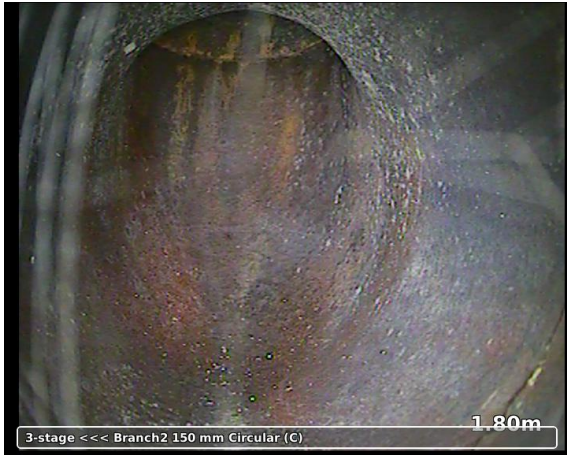
, 00:00:23, 1.80m  
Survey abandoned / Enters Bottom of RWDP

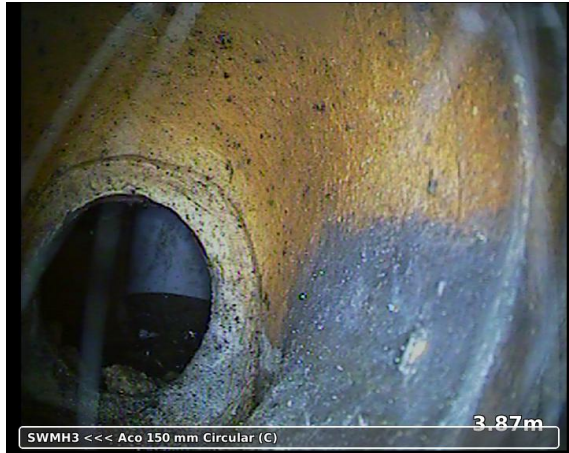
, 00:00:37, 3.87m  
Finish node type gully reference number: Aco

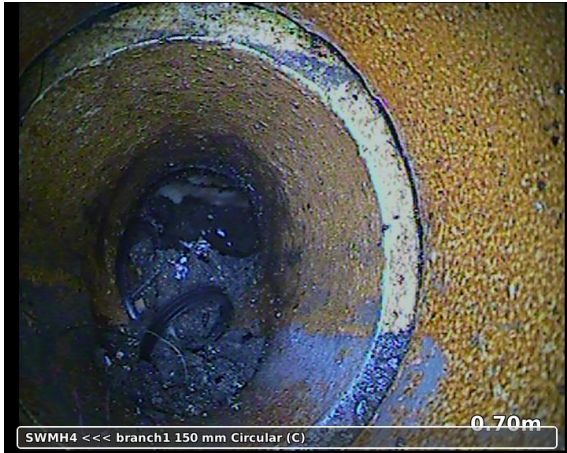
, 00:00:21, 0.70m  
Finish node type gully reference number: branch1

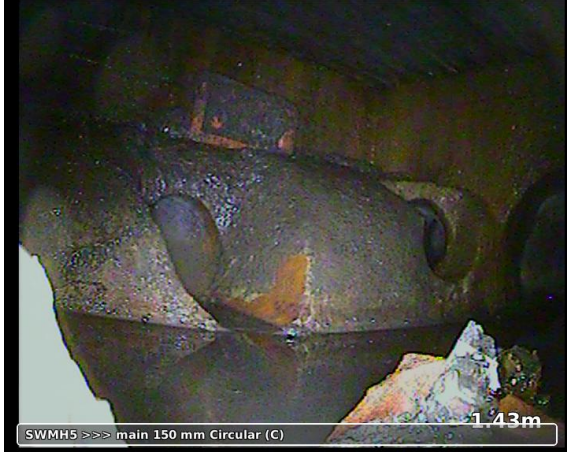
, 00:01:18, 1.43m

Finish node type manhole reference number: SWMH6

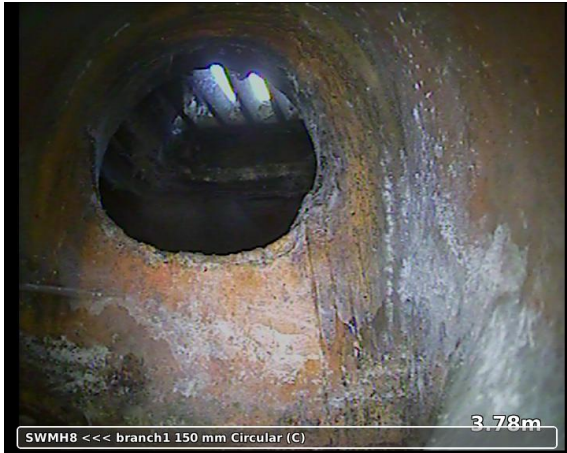
, 00:00:23, 3.78m  
Finish node type gully reference number: branch1

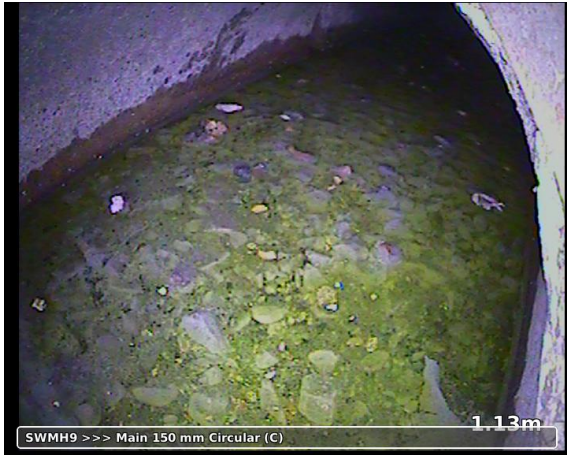
, 00:00:28, 1.13m  
Finish node type major connection without manhole reference  
number: Main

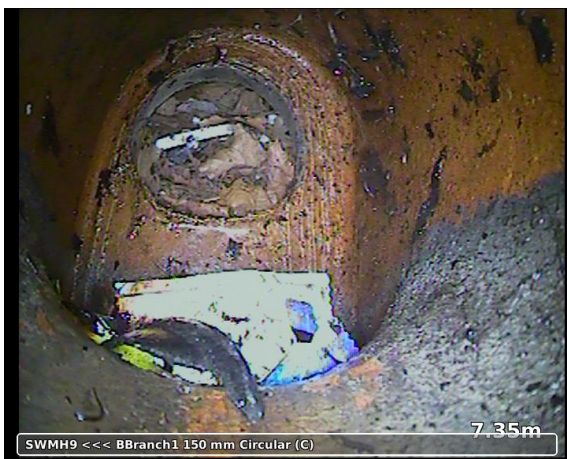
, 00:00:53, 7.35m  
Finish node type gully reference number: BBranch1 / Enters gully outlet

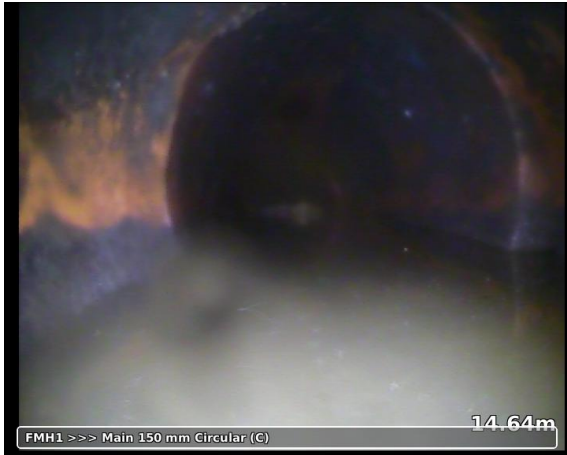
, 00:01:22, 14.67m  
Survey abandoned / Entering main sewer

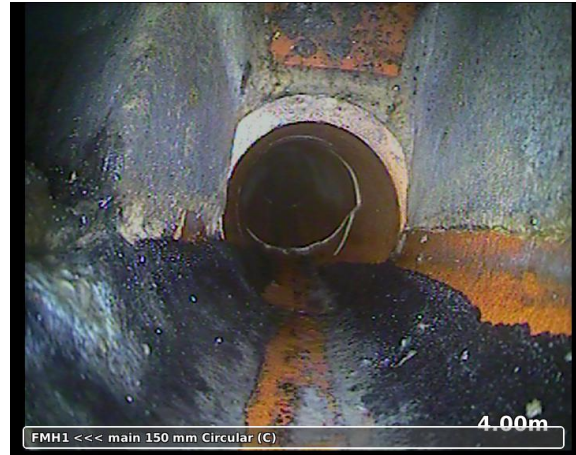
, 00:00:41, 4.00m  
General remark / Enters another chamber

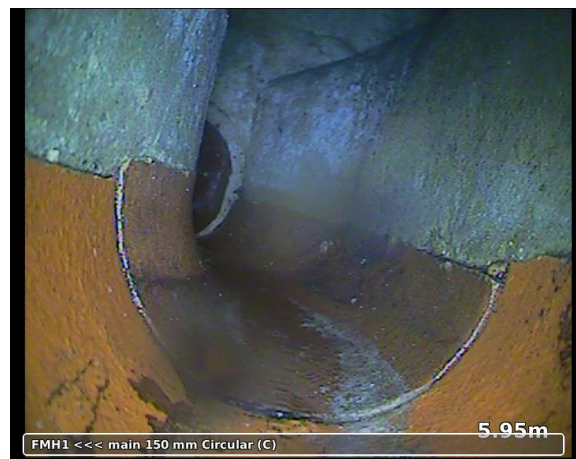
, 00:01:21, 5.95m  
General remark / Enters another chamber

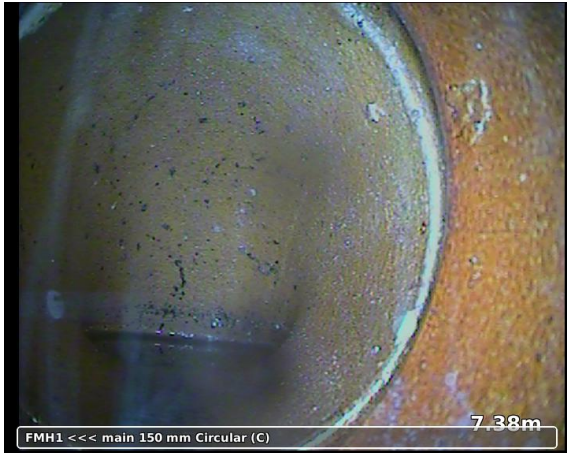
, 00:01:35, 7.38m  
Finish node type gully reference number: main

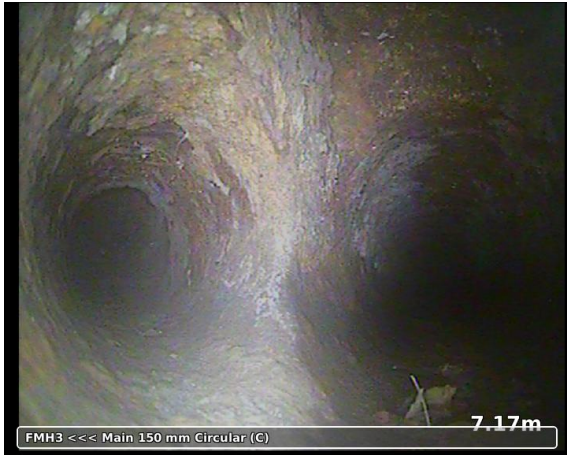
, 00:01:05, 7.17m  
General remark / Enters Burns Chamber

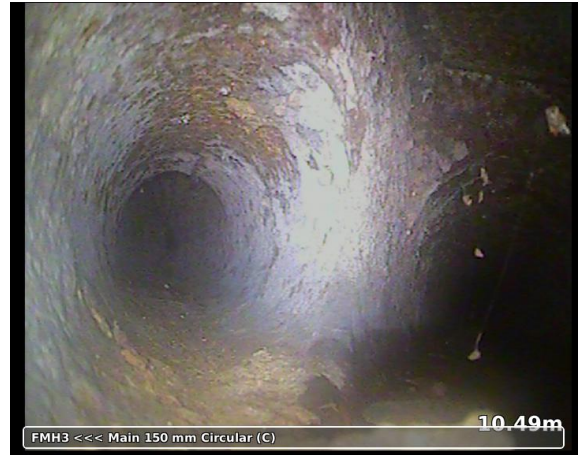
, 00:01:36, 10.49m  
General remark / Enters Burns Chamber

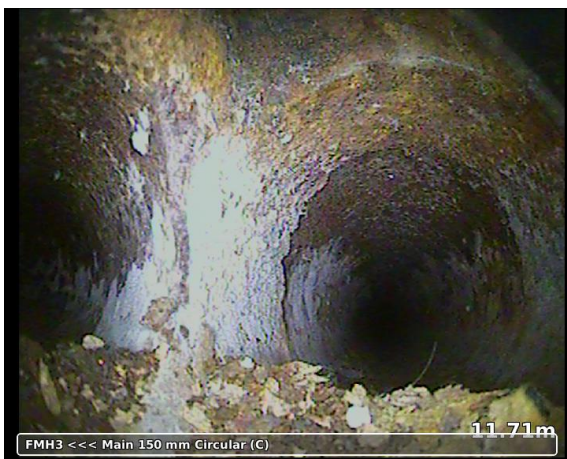
, 00:02:08, 11.71m  
Finish node type manhole reference number: Internal FMH

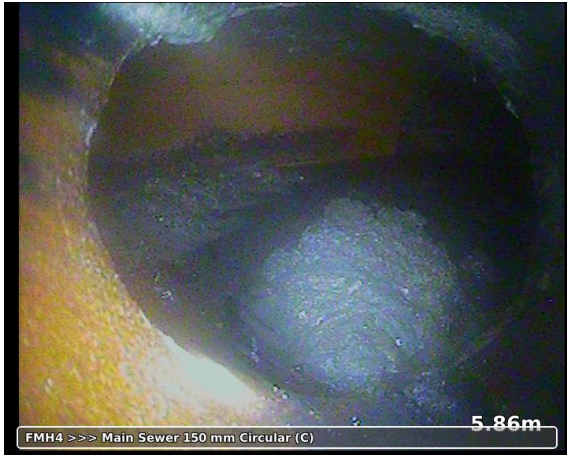
, 00:01:08, 5.86m  
Finish node type major connection without manhole reference  
number: Main Sewer
